TB-00460-01-250606

Pro4 and Flex4 cameras : Unable to Upgrade Firmware

This version: 31 October 2025

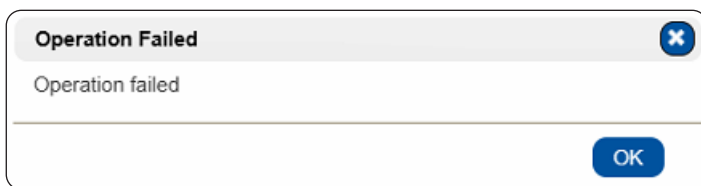
An affected camera will function normally until firmware upgrade is attempted, when it will not complete upgrade and will show an error message (**Figure 1** and **Figure 2**). Additionally, for Dual Sensor and Multisensor cameras, the upgrade process might appear to be complete but the firmware does not change and reverts to previous version.

Figure 1: Error message in GUI

A bridge firmware file must be installed to each affected camera before it is upgraded to the latest firmware.

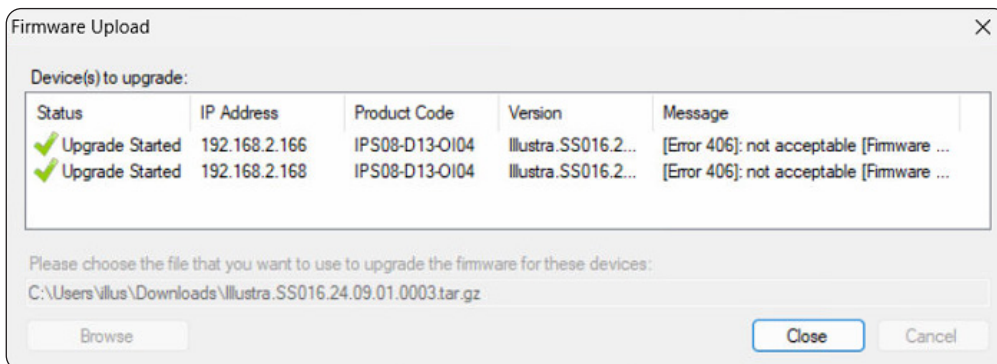
Figure 2: Error message in Illustra Connect
